Case 03.

Key upgrades (beyond the minimum 6star NatHERS) and Costs

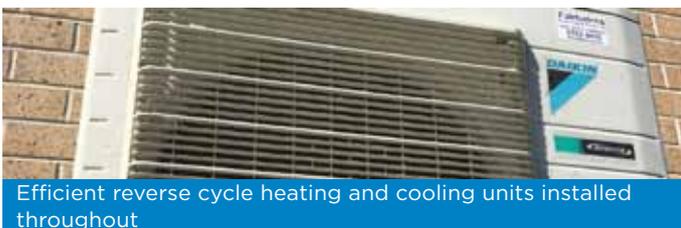
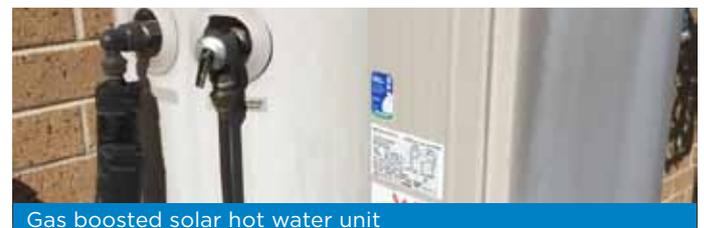
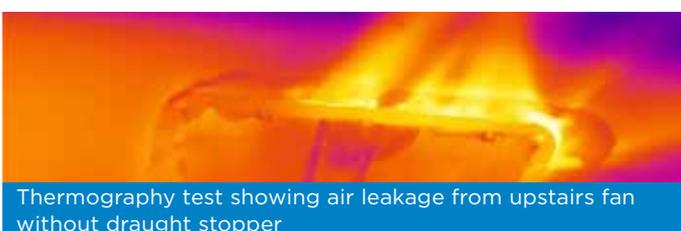
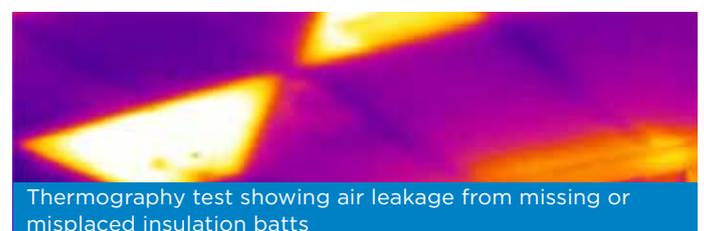
Thermography testing showed that there were approximately 6 places where batts were missing or displaced. It also showed up areas where there were air leakages around window architraves, fans and heating and cooling units.
