Western Port Local Coastal Hazard Assessment Report 2 (R02) – Data Review

October 2013

Project Name	2548-01R02v02
Client	Melbourne Water
Client Project Manager	Simone Corby/Kristina Sestokas
Water Technology Project Manager	Christine Lauchlan Arrowsmith
Report Authors	CLA, KLR, GJR, JXM
Job Number	2548-01
Report Number	R02
Document Name	2548-01R02v02a_DataReview

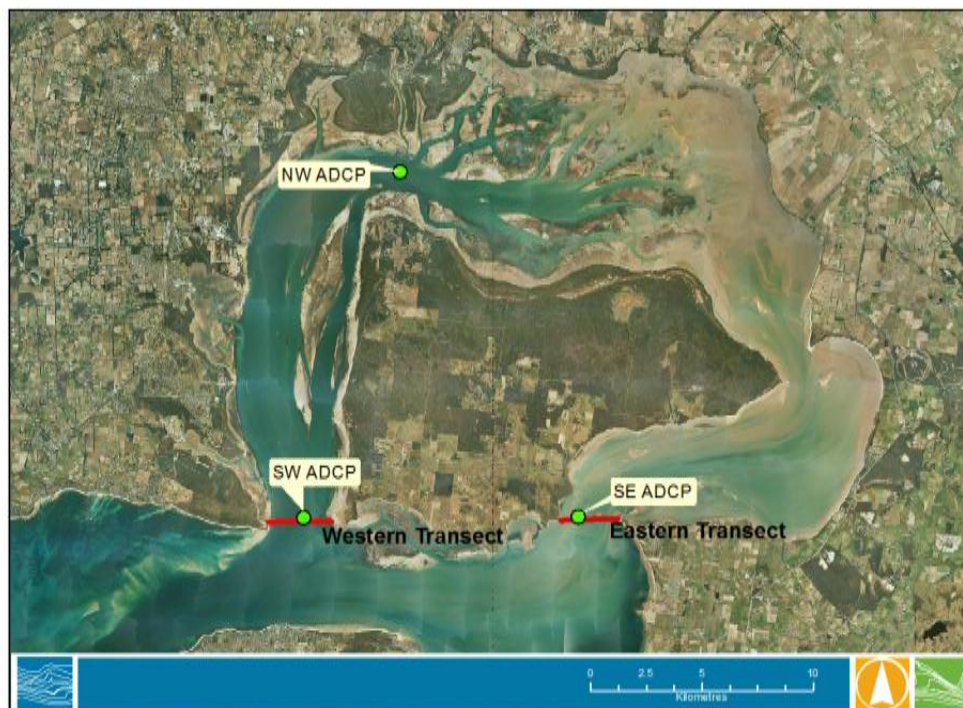
Figure 2-6 Location of ADCP transects in Western Port

The ADCP transect measurements were conducted over a typical spring tidal cycle over the 14th and 14th of June, 2011, and provide lateral and depth averaged current speed, and flux through both the Western and Eastern arms. The location of the ADCP transects is shown in Figure 2-6.
